# 100 Largest Losses in the Hydrocarbon Industry 1974-2019

# 100 Largest Losses in the Hydrocarbon Industry, 1974-2019

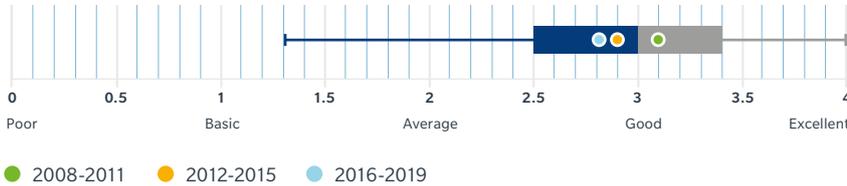
**Average engineering standards at refineries declined during 2008-19.**

*Deterioration in refining engineering standards (each circle represents the average score for the respective four-year period).*

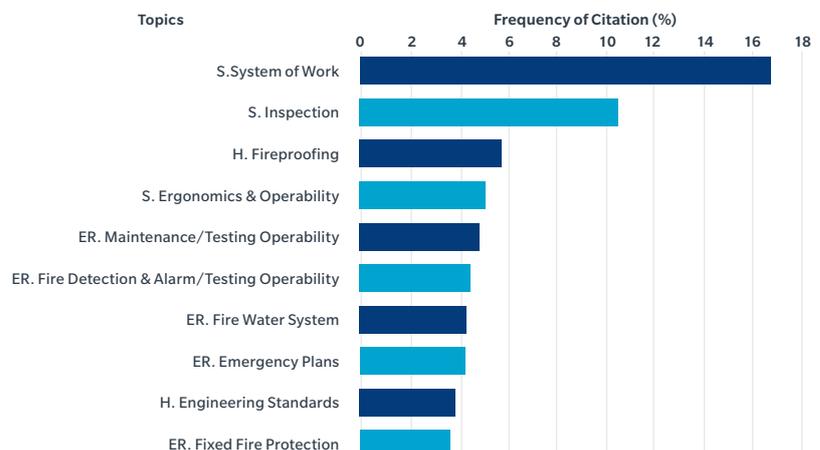
Systems of work was the most frequently cited topic.

The most commonly cited risk recommendation topics by Marsh over the past few years (see chart below), reinforce the view that the same issues are still observed today as they were in 1988-1989.

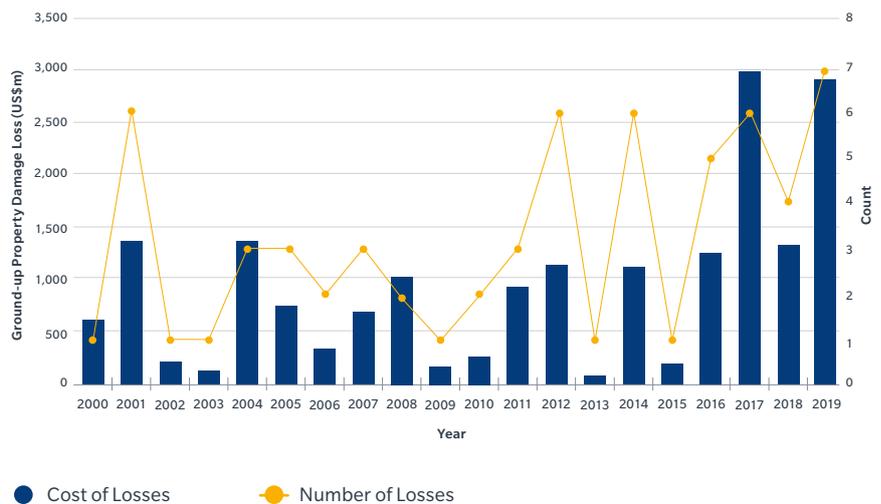
The number and total cost of property damage losses have both risen in recent years.

The onshore oil and gas sector has recently experienced a rise in the number of property damage losses per annum in excess of US\$100 million. The period 2016-2019 was particularly poor, with property damage losses well in excess of US\$300 million occurring at refineries in North America and Europe, all of which were originally built in the 1960s or earlier.

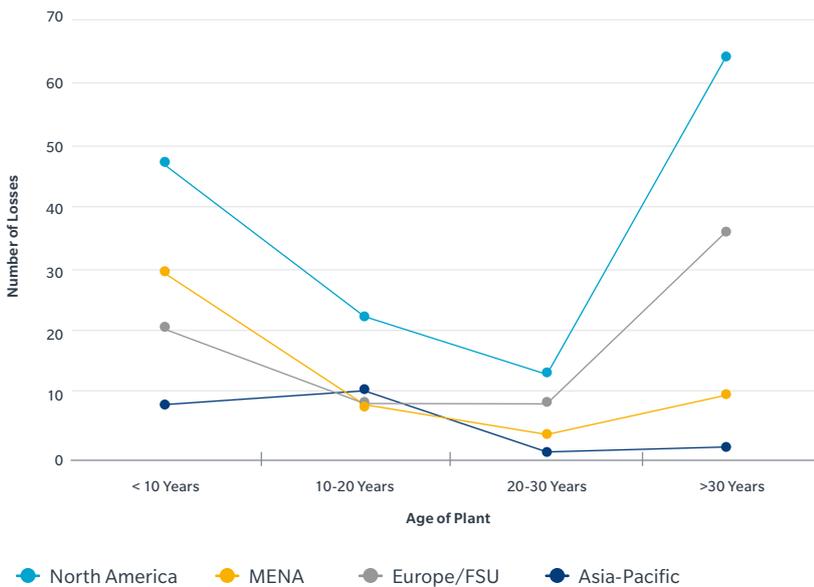
FIGURE 11

North America experiences the largest number of losses, which follow a "bath-tub" curve.

The largest number of losses have occurred in North America (see figure 11) followed by Europe, Middle East/North Africa (MENA), and Asia-Pacific (excluding China).

The MENA and Asia-Pacific regions do not yet follow the traditional "bath-tub curve," primarily due to the younger age of their operating plants compared to Europe and North America, which have similar shapes. As plants in the MENA and Asia-Pacific regions age, we may see similarly shaped "bath-tub curves" develop.

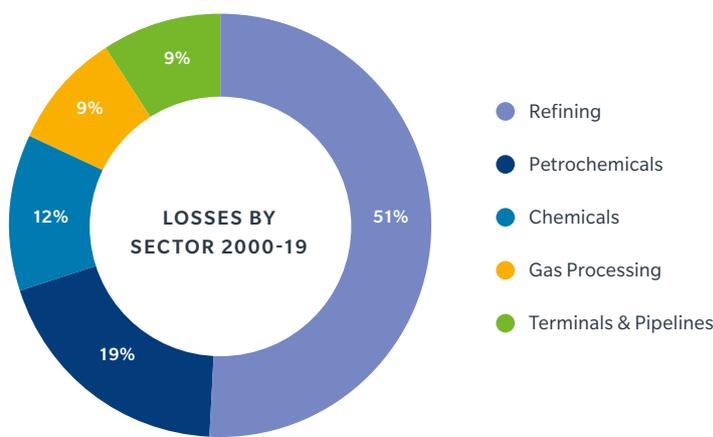
Refining accounts for more than half of all losses during 2000-19.

The oil sector, principally refining (including Canadian Oil Sands), is the major industry contributor to major losses (constituting 51% of all losses — see figure 12), with the petrochemicals sector a distant second place (19%). This can at least partly be attributed to the highly corrosive nature of crude feed-stocks and processes, which presents challenges both to ensure that metallurgy is up to current standards and for inspection departments.
